*TRINITY RIVER AUTHORITY CLEAN RIVERS PROGRAM*  
**2016 BASIN HIGHLIGHTS REPORT**

PREPARED IN COOPERATION WITH THE  
TEXAS COMMISSION ON ENVIRONMENTAL QUALITY

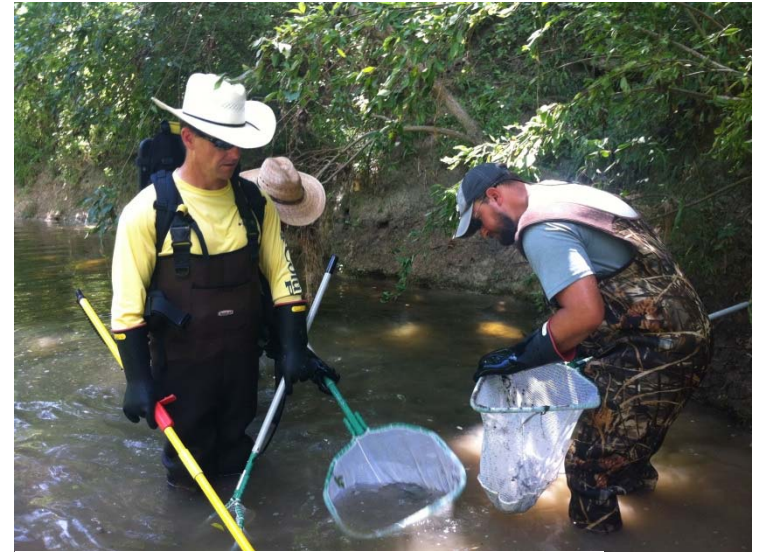
Image 2: Electrofishing, Red Oak Creek

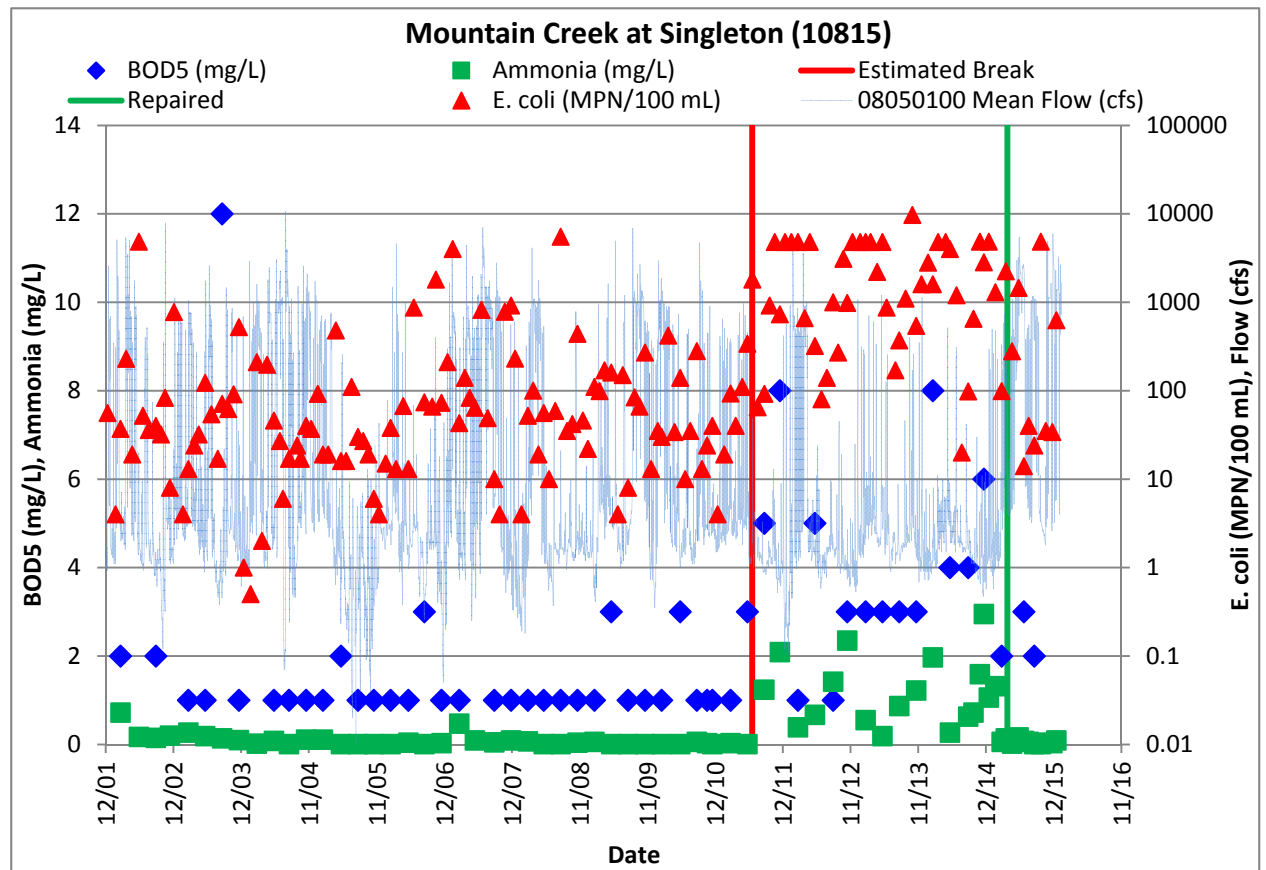
Figure 3: BOD5, Ammonia, and *E. coli* for Station 10815

During data analysis for the 2015 Basin Summary Report, a trend was discovered at 10815 site in Mountain Creek (0841O), just upstream from the confluence with the Trinity River. This site displayed increasing trends for several parameters including BOD5, Ammonia, and *E. coli*. More importantly, the increasing trends were a result of sharp increases in values for these parameters starting in mid-2011. Further data analysis showed that the sudden increase in values coincided with a prolonged decrease in lake levels in Mountain Creek Lake and flow in Mountain Creek itself. Drought can cause ground shifting due to decreased soil moisture and damage to underground infrastructure.

In coordination with staff at the TRA Central Regional Wastewater System, a pipeline was identified that had a semi-exposed crossing over Mountain Creek. Field reconnaissance and testing in late-March 2015 found that this pipeline was broken in several places. The owner of the pipeline was notified and repairs were made immediately. As shown in Figure 3, levels of BOD5, Ammonia, and *E. coli* decreased following the repair (green vertical line). There are some elevated *E. coli* levels following the repair; however, this is attributed to runoff from the extreme high flows that have been prevalent in the watershed since early 2015.

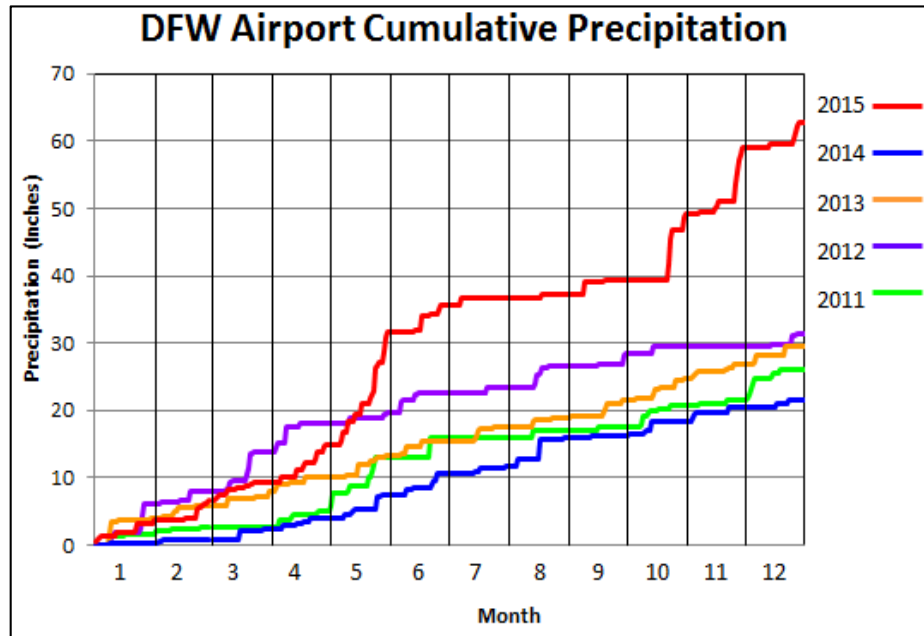
Figure 4: DFW Airport Cumulative Precipitation for 2011 to 2015

2015 set a record for cumulative precipitation in many parts of Texas. Based on the NOAA gage at DFW Airport, 2015 was the wettest year on record with 62.8 inches of precipitation. This exceeds the previous record year of 1991 by more than 9 inches and is equal to the amount of precipitation recorded in the preceding two and a half years from June 1, 2012 to December 31, 2014. Figure 4 below illustrates the cumulative total precipitation for the past five years as measured at DFW Airport.

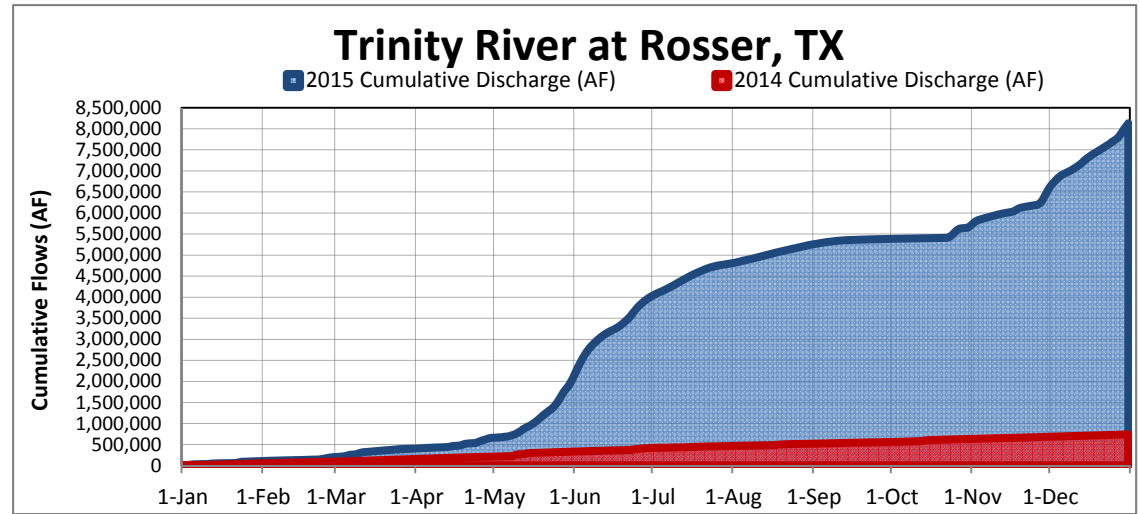
Figure 5: 2014 and 2015 Cumulative Flows, Trinity River at Rosser

Figure 5 shows the cumulative flow in acre-feet that passed by the USGS gage near Rosser for both 2014 and 2015. In 2015, more than 10 times as much water passed by the gage than in 2014. Additionally, the total 2014 volume was exceeded by mid-May 2015.

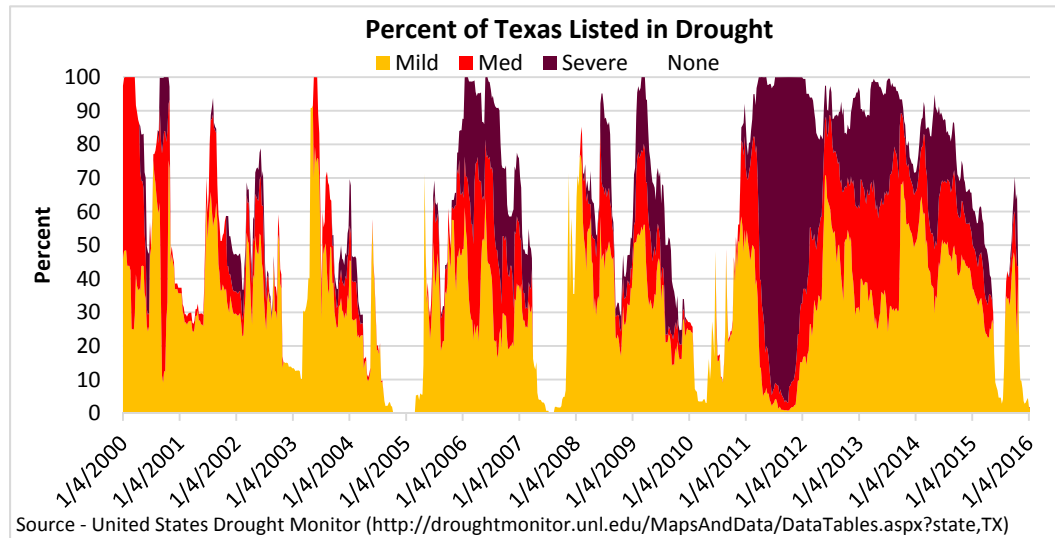
Figure 6: Percent of Texas Listed in Drought

Prior to the heavy rainfalls of 2015, much of the state was in varying degrees of drought with 2011 being especially severe. Figure 6 shows the percentages of the state that were listed as being in mild, medium, or severe drought. The rains in early-2015 brought most of the state out of drought. This was followed by a “flash drought” during the summer which was then relieved by the fall and winter rains. As of mid-January 2016, less than five percent of the state was in drought.

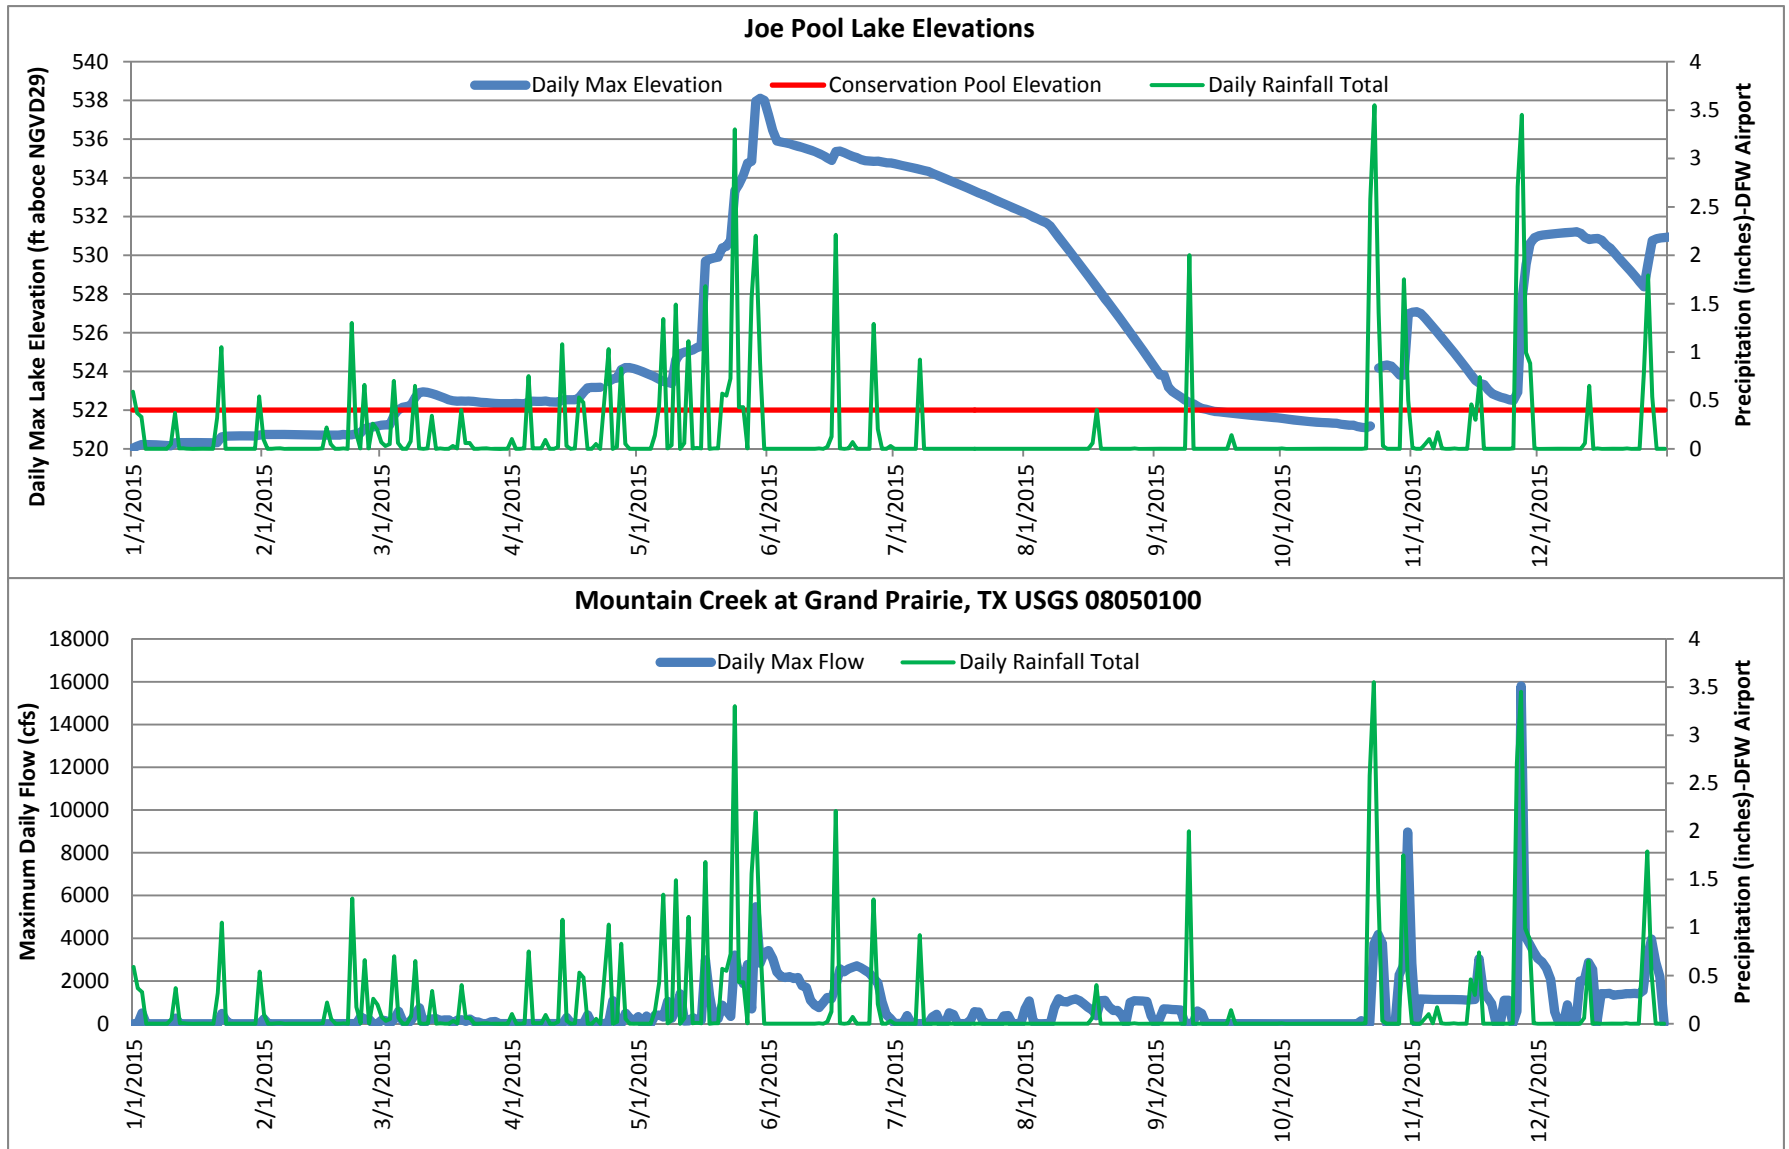
Figure 7: Joe Pool Lake Elevation and Downstream Flow

The flooding that resulted from this unprecedented rainfall was especially pronounced in the Trinity River basin. Many reservoirs have been at or above normal pool elevation for much of the time since March/April 2015. Many of these are flood control reservoirs and, as a consequence, the controlled releases have prolonged the elevated stages seen in the river downstream of these reservoirs. The following graphs (Figure 7 to Figure 11) show water surface elevations for several basin reservoirs as well as flow at the downstream river gages.

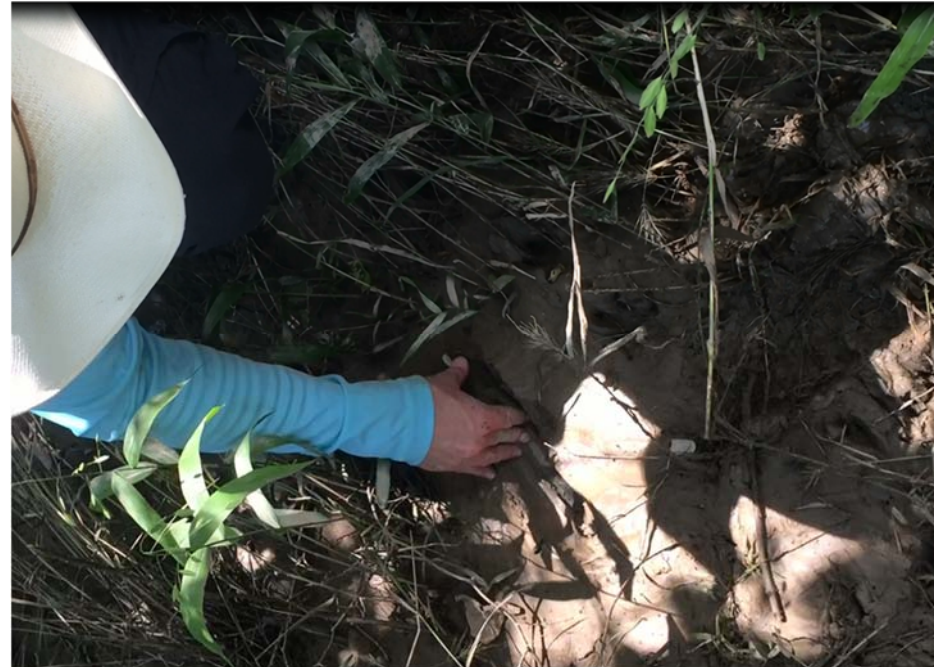
Image 9: Overbank sediment deposition being measured and removed from atop a hardened benchmark at site 080444

As part of the 2015 study, field data was collected at three sites to better characterize the biology, geomorphology, and hydrology of each site. After initial site selections were made, hardened benchmarks (Image 9) were secured and mapped with RTK GPS (Image 10). Data collected included:

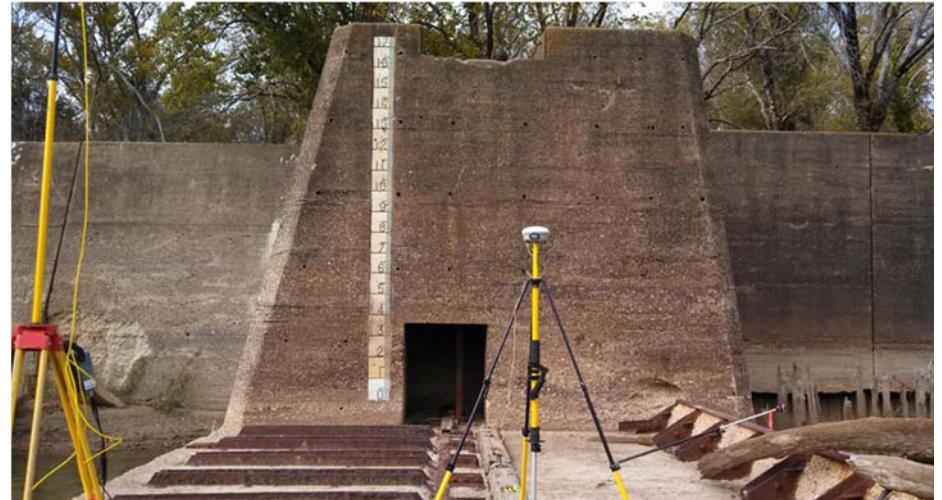
Image 10: RTK GPS base station setup at relic lock near 080444

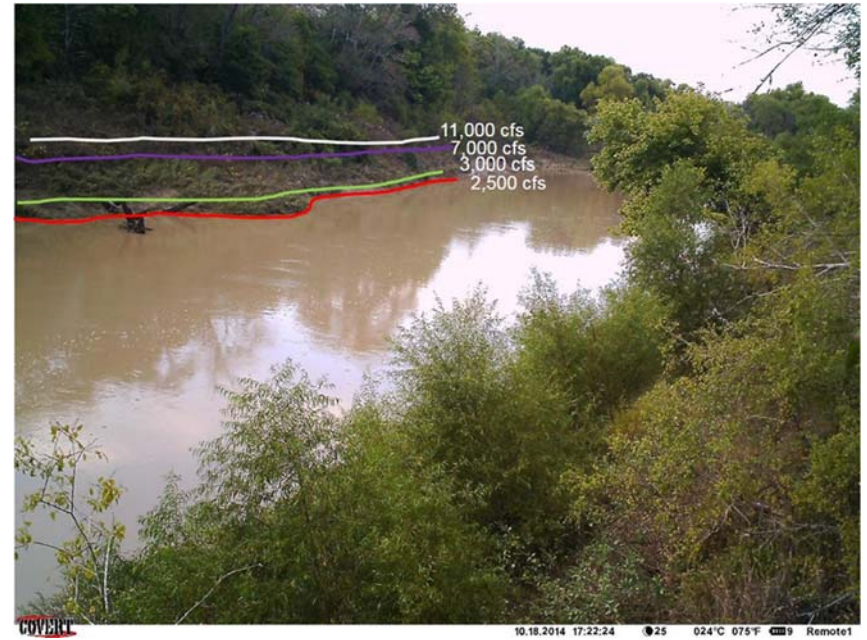
Image 11: Remote camera installation captures varying river stages near site 080295

1. Photographic – automated time-lapse camera and standard photographs (Image 11);

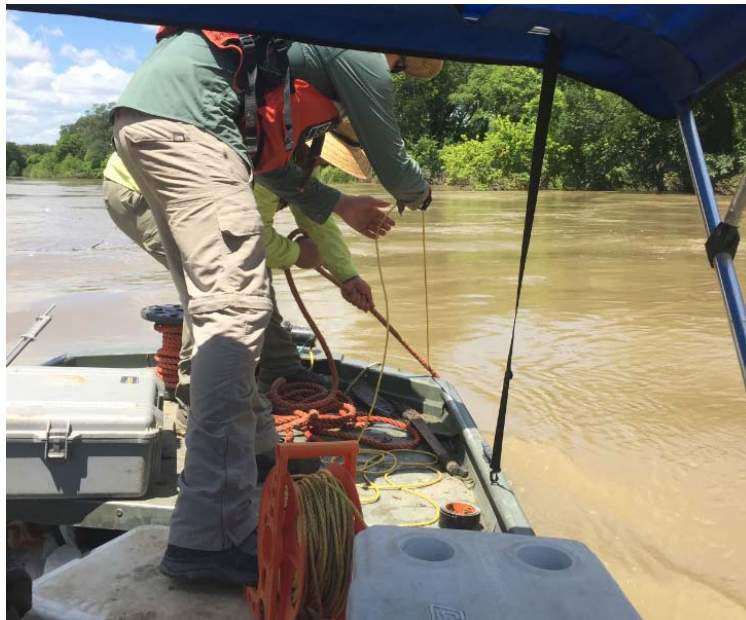
Image 12: Field staff attempt to capture bed sediment at site 080444

2. Sediment – suspended and substrate/bed (Image 12);
3. Flow – acoustic Doppler and wading rod, as required (Image 13);
4. Survey – benchmarks, cross-section, water surface profile, and longitudinal (Image 14);
5. Pressure transducers (PT) – water level time-series on-site;
6. Riparian – tree, sapling and seedling counts along a transect; and
7. Field observations and notes.

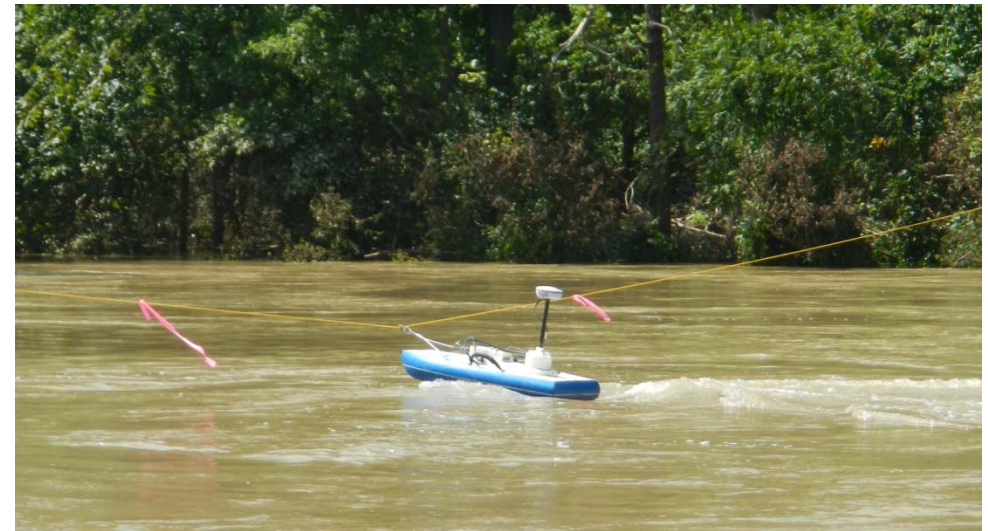
Image 13: Moving bed calculations being performed by acoustic Doppler profiler during high flows at site 080295. Similar methods are employed to calculate flow (Q) data.

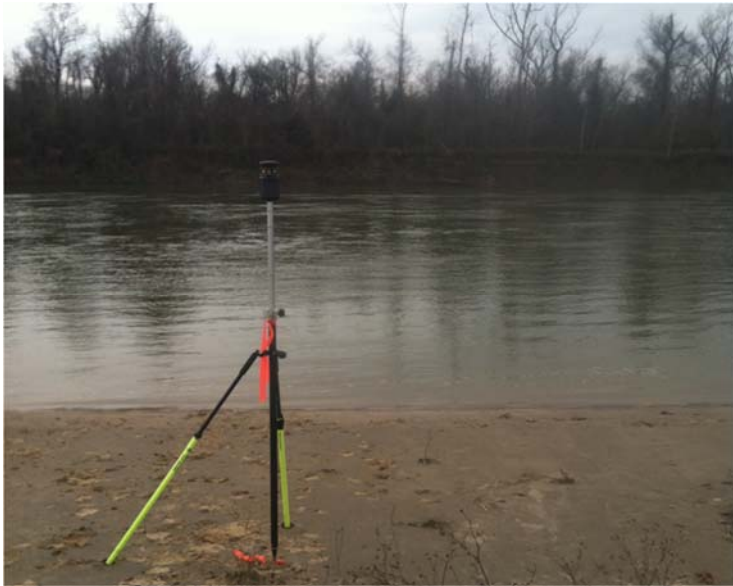
Image 14: Cross-sectional survey being performed with robotic total station at Site 080075

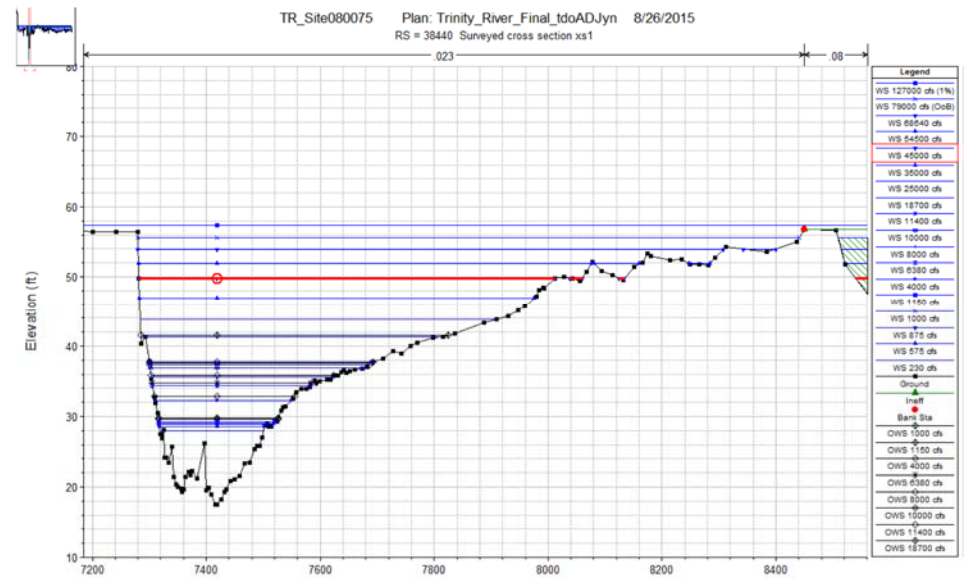
Image 15: Modeled and observed HEC-RAS water surface elevations

These data fed the development of HEC-RAS models at the sites (Images 15 & 16). Future data needs and recommended additional studies were also outlined in the full report which was completed in October 2015. The report is available on the Trinity River Authority website (<http://serv.trinityra.org/reports/BasinSummaryReports/LiDARandEnvironmentalFlowAssessmentofTrinityRiverFinalReport.pdf>).
